# Case Study #52 - EPDM Best Western Inn

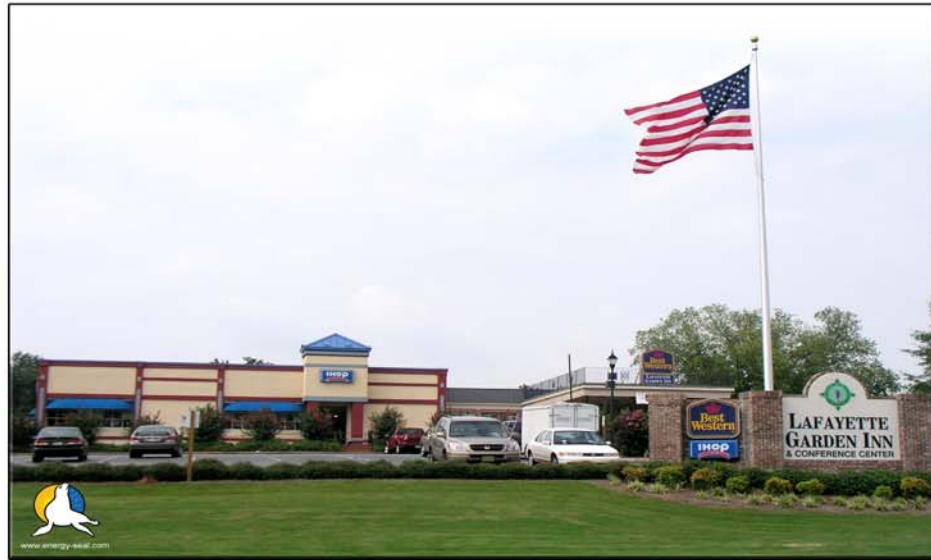
This building had an aged black EPDM roof which was showing signs of accelerated aging and wear. The roof had numerous roof leaks and was reaching the end of its useful life.

The Energy Seal Coatings EPDM roof coating system was specified and installed on this project.

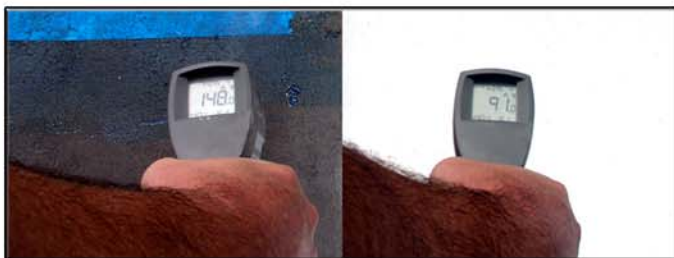
As an Energy Star labeled product, Acu-Shield acrylic elastomeric roof coating was able to reduce the roof temperature of this project by 57°F. This heat reduction will provide energy savings and will greatly extend the service life of the roof.
