# A Tough System for a Tough Job

## KEEPING DRY UNDER DIFFICULT CIRCUMSTANCES

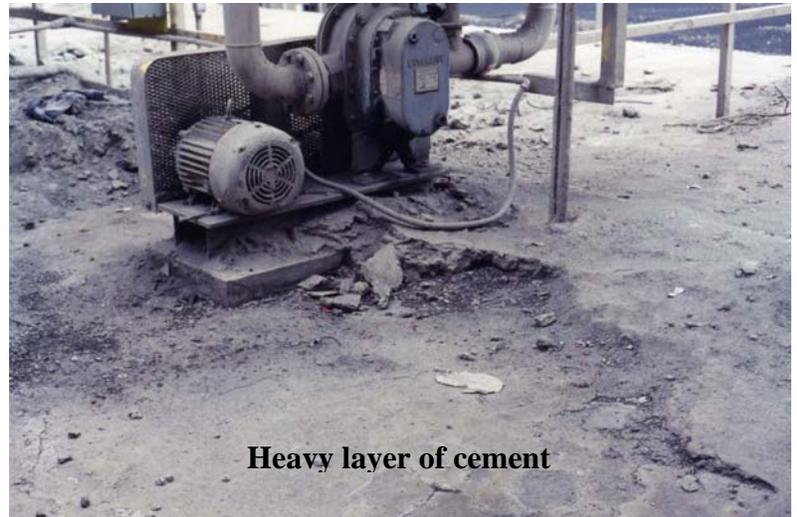
**Heavy layer of cement**

On top of the storage silos a large layer of cement built up over the years. This had to be removed before waterproofing the deck. Jackhammers were used on the larger pieces of cement and needle guns and grinders removed the material off of the roof deck, perimeter and equipment...a very expensive and time consuming process.

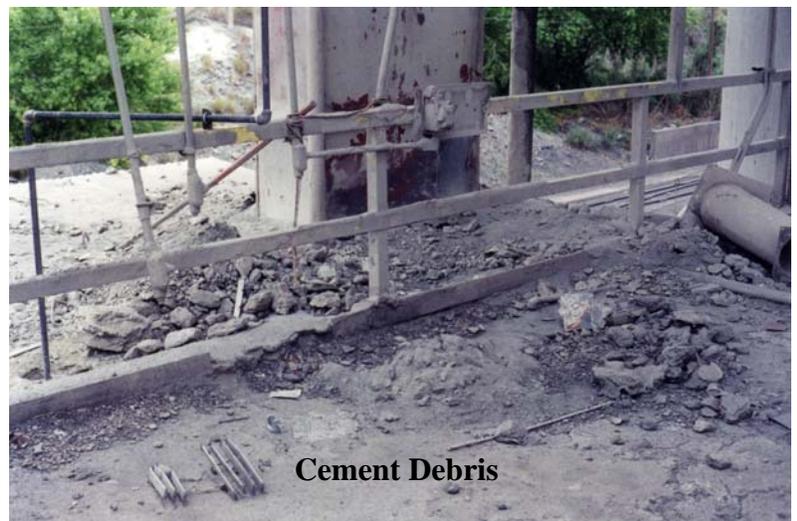
**Cement Debris**

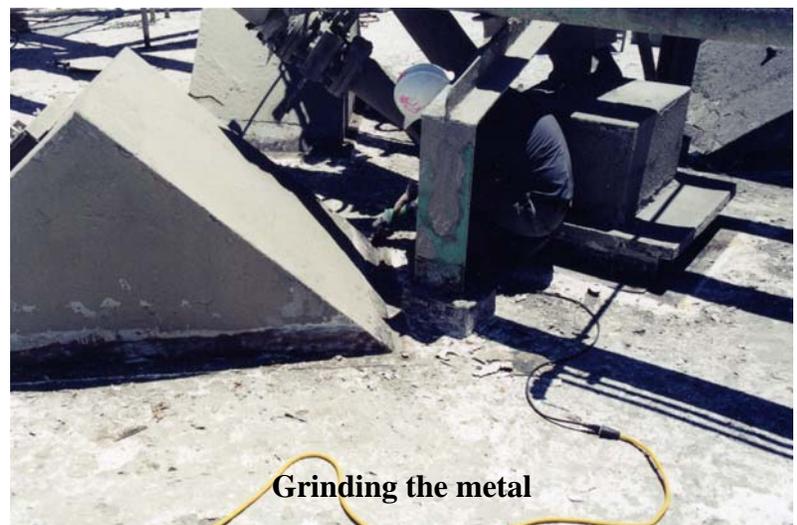
**Grinding the metal**

Perimeter metal and flashings were primed and two layers of Energy Seal's Acu-Caulk Brush Grade and Acu-Fabric polyester were applied.

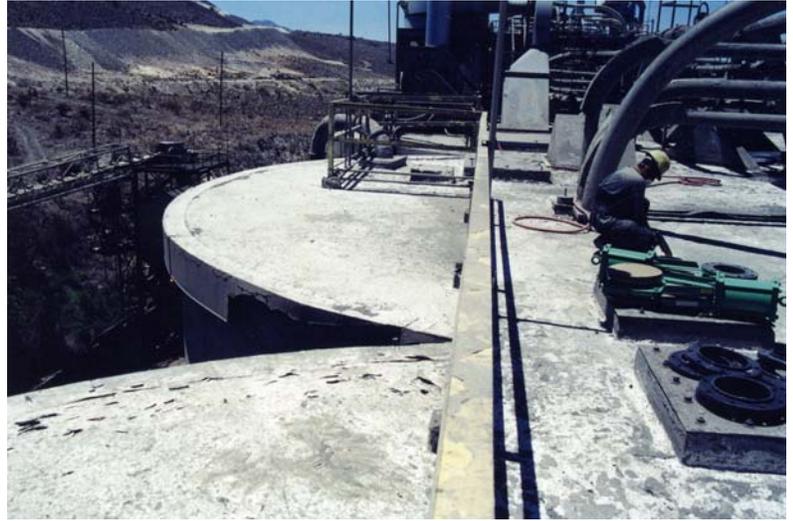
The roof deck stripped of cement. It is now ready for priming

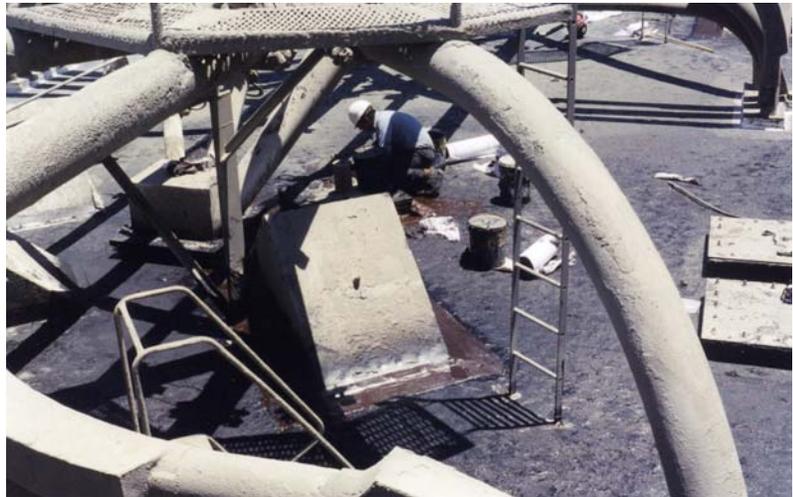
Equipment and flashings are prepared on the primed roof deck.

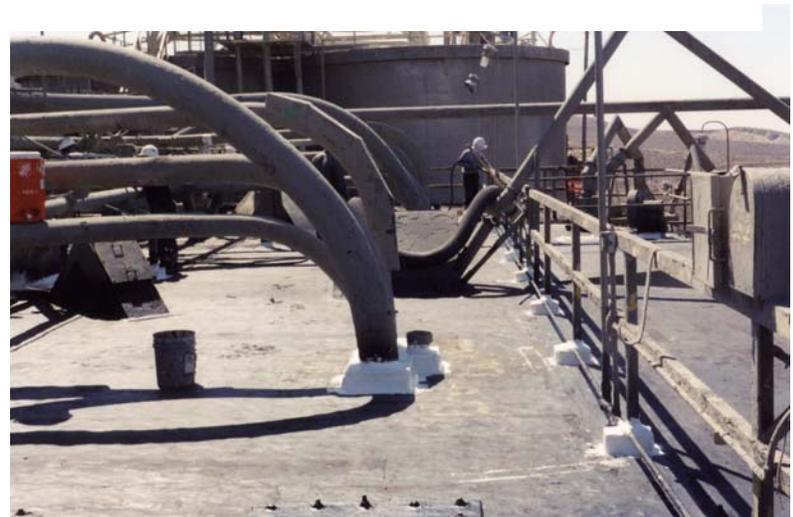
After the roof deck was primed all pitch pockets, boxes, flashings and equipment was sealed with Acu-Caulk and Acu-Fabric polyester by Energy Seal Coatings, Inc.

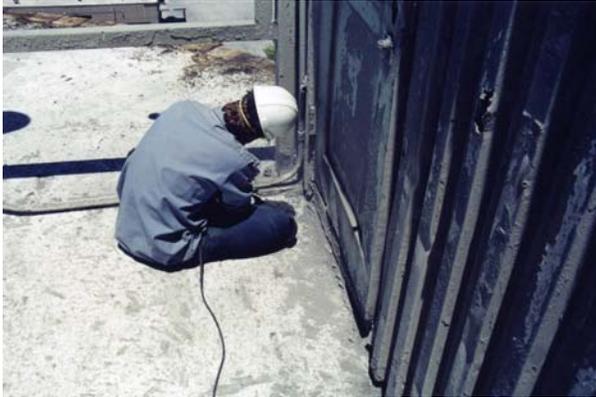
**This penthouse needed special attention.**

**1<sup>st</sup> photo.** All embedded concrete behind the wall was removed.

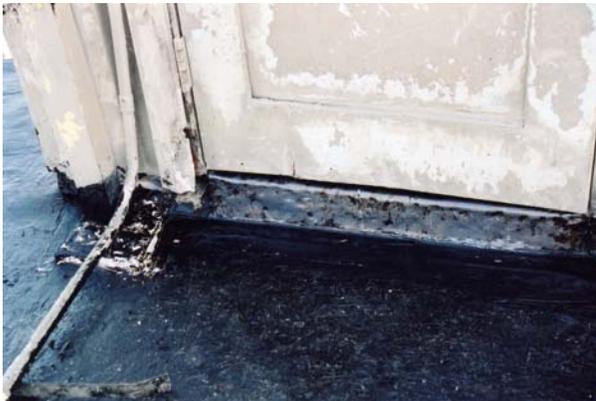
**2<sup>nd</sup> photo.** To keep the deck watertight a lead flashing was installed completely around the base as a counter flashing.

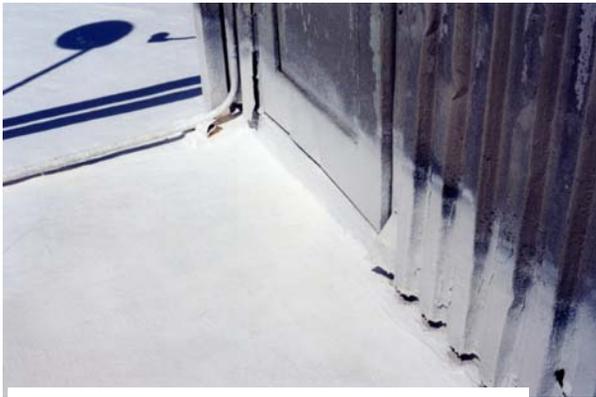
**3<sup>rd</sup> photo.** The finished roof

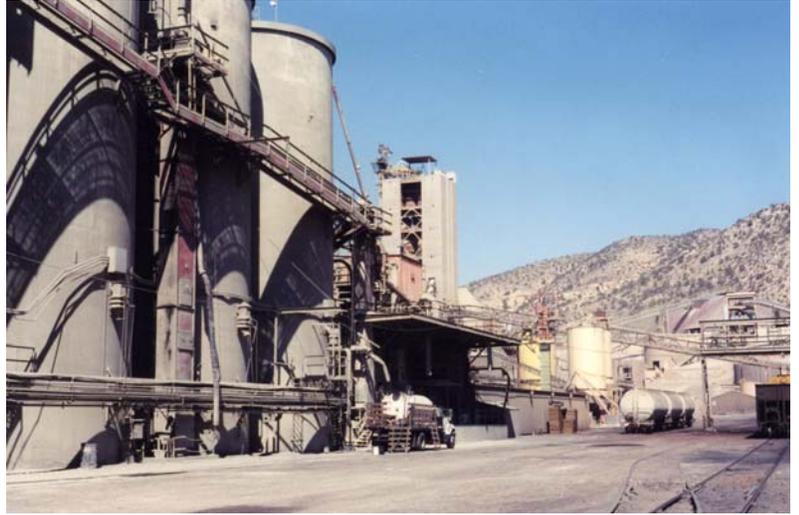
After the roof deck was prepared, the rubberized emulsion was pumped from our tanker to the top of the silos.

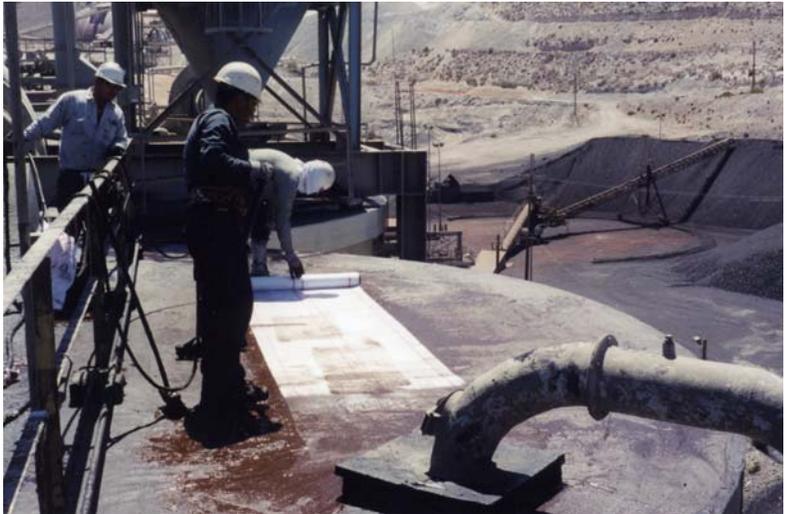
Acu-Fabric being applied with rubberized emulsion

The original concrete deck was irregular. After the deck was primed, 6 gallons per 100 square feet of rubberized emulsion was applied to the roof deck followed by 1 layer of soft polyester. This process was repeated for a total of 2 layers. Using soft polyester allowed for the waterproofing system to mold to the concrete deck avoiding any air pockets or voids. A final coating of 6 gallons per 100 square feet of rubberized emulsion completed this phase of the job.

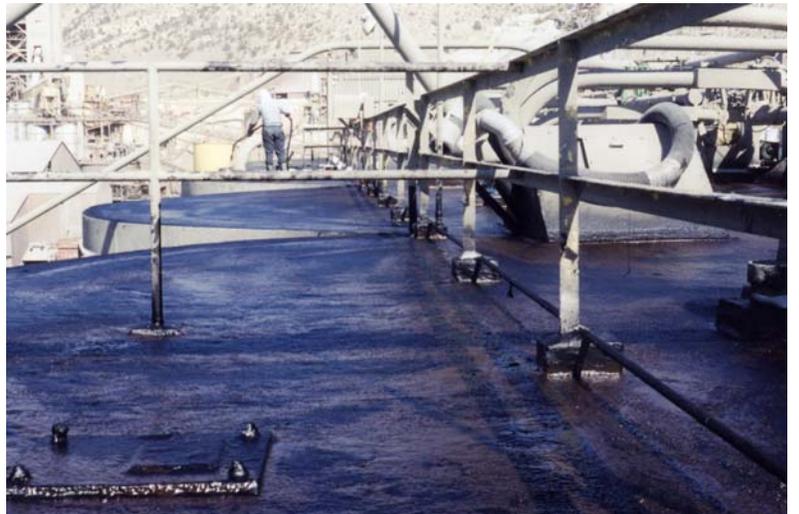
A heavy coating of rubberized emulsion being applied on top of two layers of Acu-Fabric and emulsion

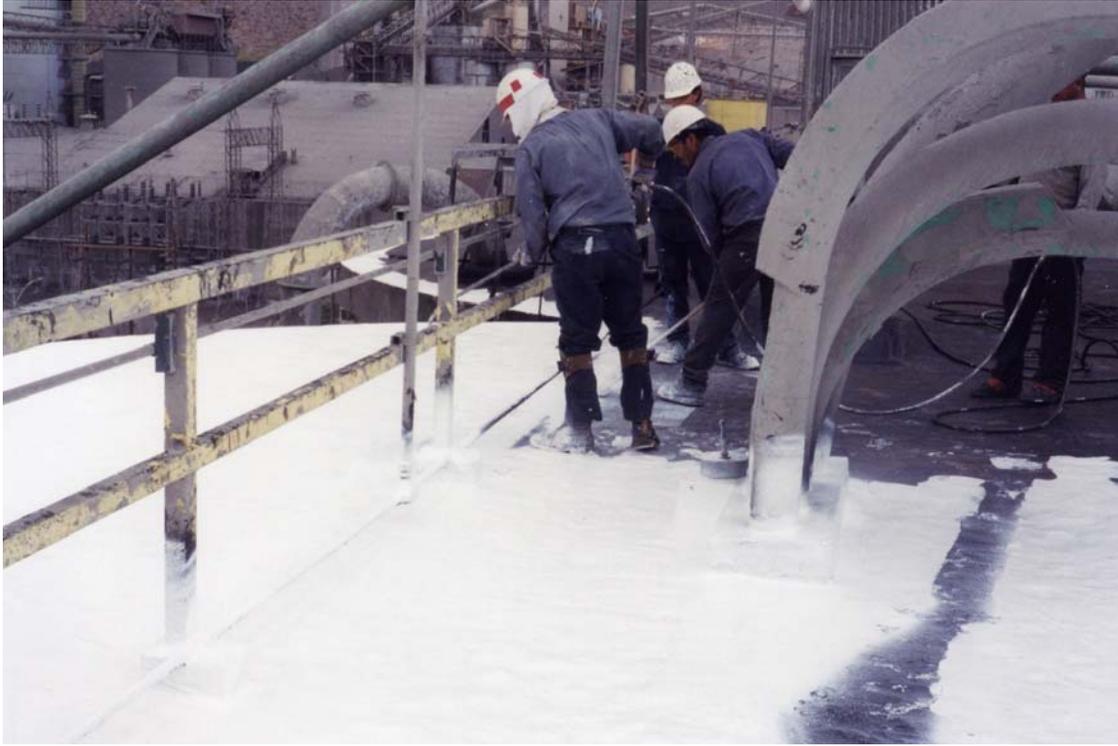
Spraying the first layer of Energy Seal's Acu-Shield onto the roof deck

After the rubberized roof cured, Energy Seal Coating's Acu-Shield acrylic coating was applied at the rate of 2 gallons per 100 square feet. After the acrylic coating dried and cured 1 gallon per 100 square feet of Acu-Flex Hydro was applied. The coating blocks 90% of the sun's UV rays and protects the new system from the hot desert sun. It will also stretch along with the rubberized material underneath, giving the roof flexibility.

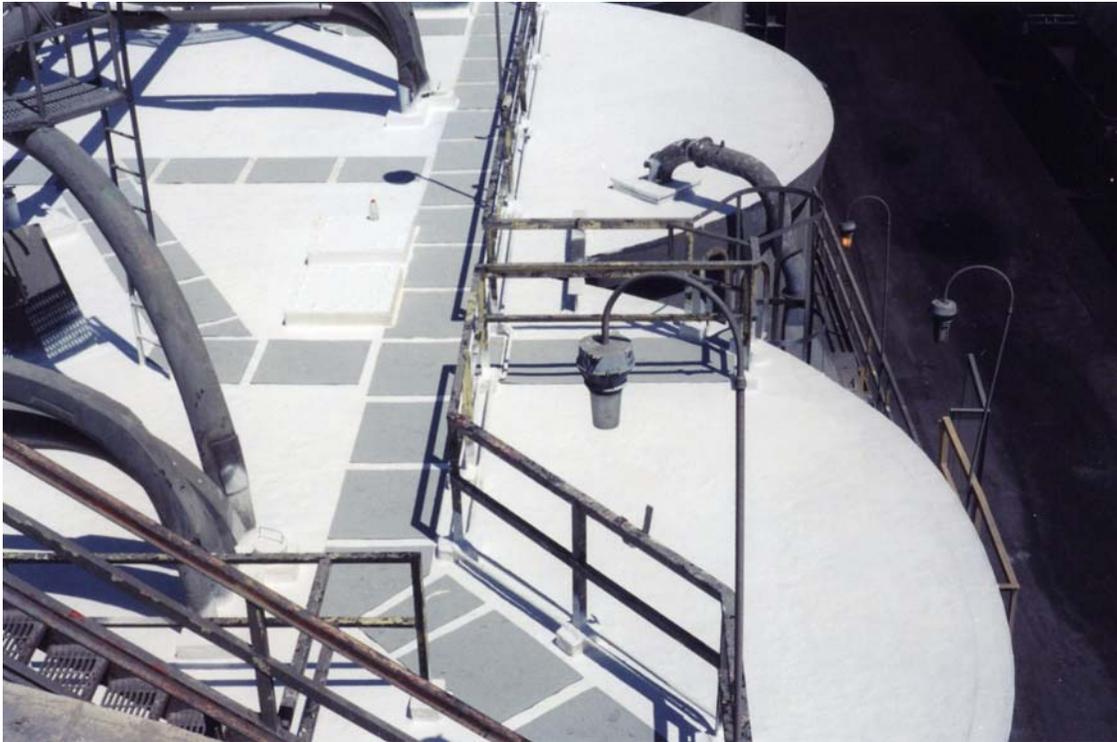
The roof with walking deck installed

Once the whole roof system was complete a walking deck was installed to all of the high foot traffic areas.
