KTLA MT. Wilson

When a roof absolutely positively cannot leak, what are you going to use?

Polyester & Rubberized Emulsion Extra Tough Roof

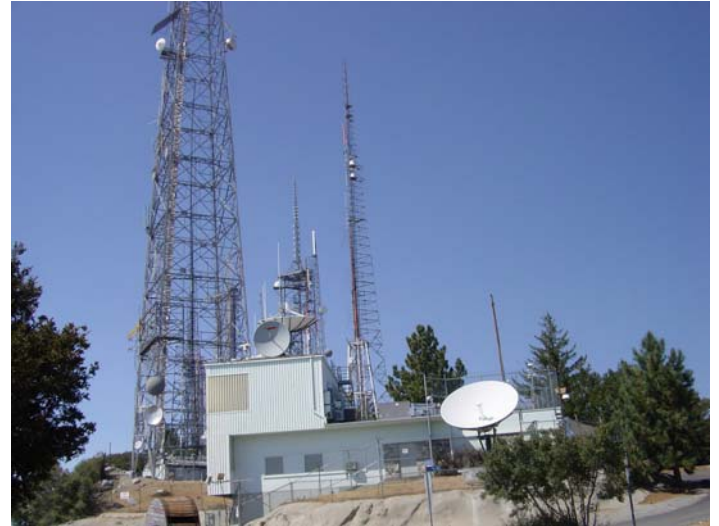
KTLA building housing the complex electronic equipment for signal broadcast.

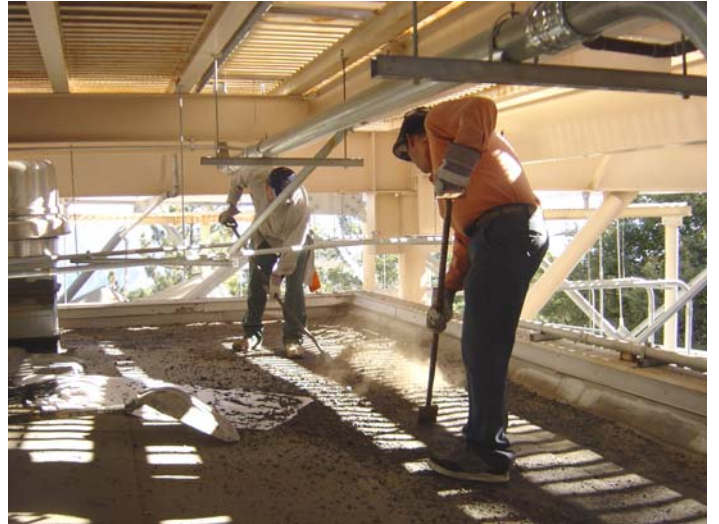
Rock is spudded off and removed.

The roof had an overhead deck covered with an ice shield making it tough to work on the roof. The workers had to labor in a crouching position to get the job done. Rock in the valleys of the roof had to be spudded off and primed before the emulsion maintenance system could be installed.

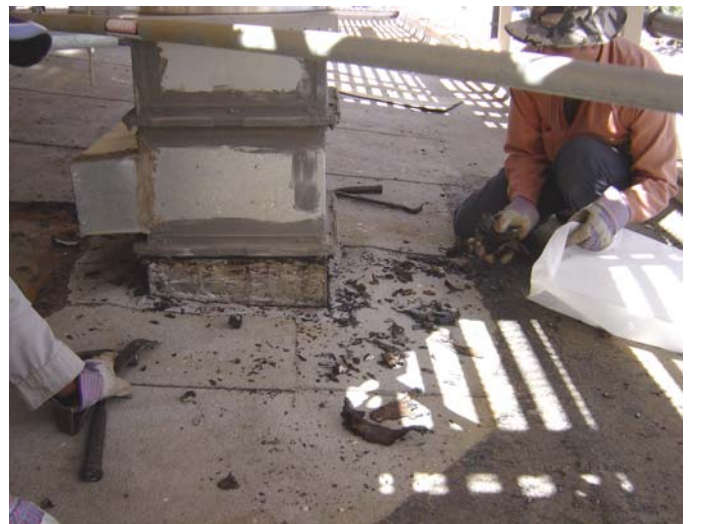
All vents and pipes are scraped down and prepared for the Energy Seal's Acu-Caulk: Brush Grade.

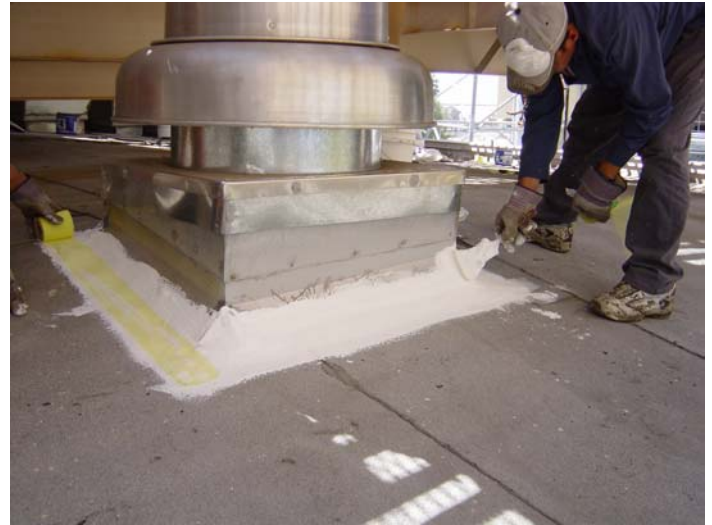
Elastomeric cement is reinforced with fiberglass around all vents.

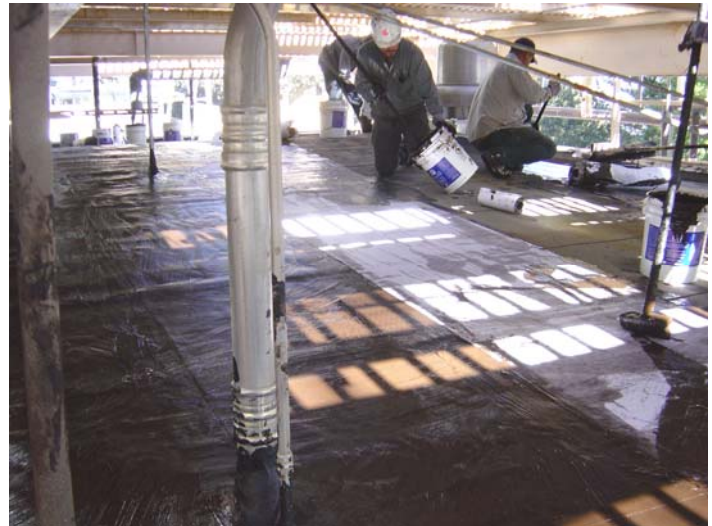
Installing polyester and rubberized emulsion.

Six gallons per 100 square feet of rubberized emulsion was applied to the roof deck followed by one layer of Acu-Fabric. This process was repeated for a total of two layers. A final coating of six gallons per 100 square feet of rubberized emulsion completed this phase of the job.

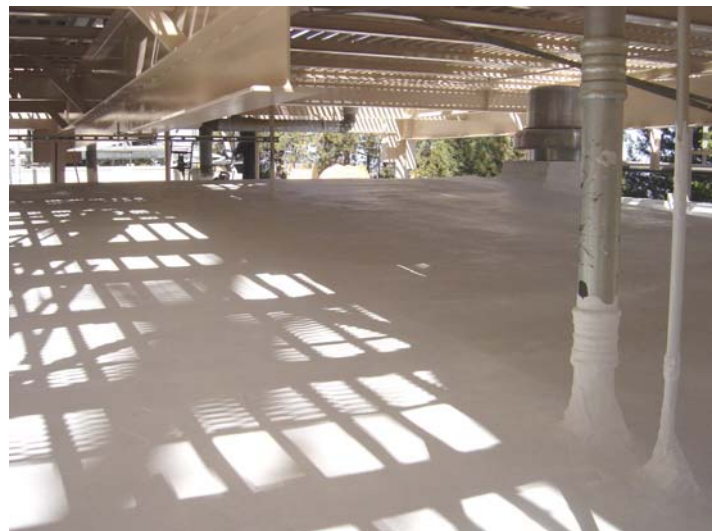
The finished roof

After the rubberized roof cured, Acu-Shield white acrylic coating was applied. The acrylic coating blocks 90% of the sun's UV rays and protects the new system from the high altitude sun. It will also stretch along with the rubberized material underneath, giving the roof flexibility.

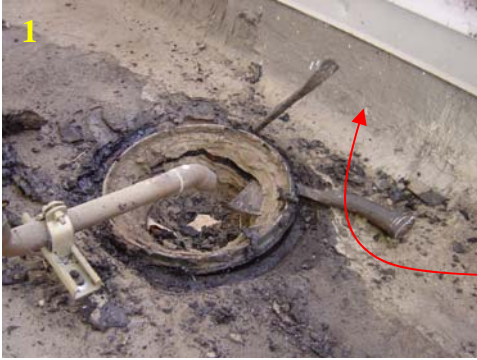
The collar on this jolsum drain is cut back.
Notice that the overflow has been covered up.

Flashings were primed and two layers of an Energy Seal's Acu-Shield and Acu-Fabric were applied. The drains on the roof were cut back and a lead sheet that would allow expansion and contraction was installed. Rubberized elastomeric cement was applied and two layers of Acu-Fabric polyester embedded into the rubbery material around the drains.

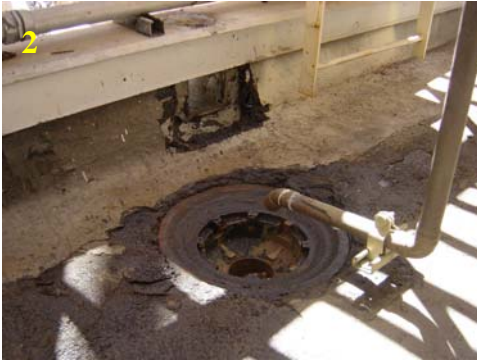
The old roofing material has been cut away from the drain and overflow.

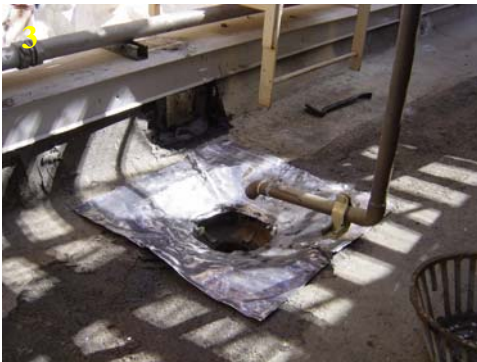
A piece of lead is shaped for the drain.

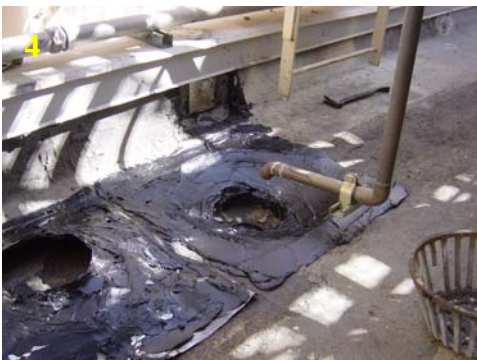
Henry's 209 flexible mastic is applied to both the lead and the area around the drain.

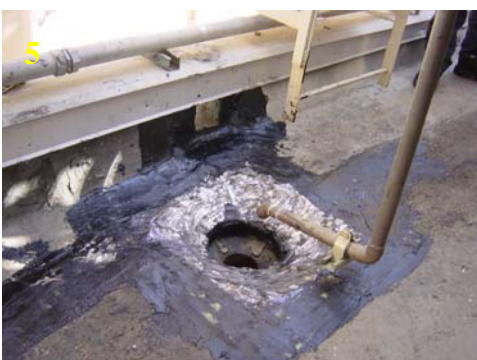
The lead is pressure sealed to the drain.
Henry's 209 and fiberglass web are set around the perimeter of the drain.

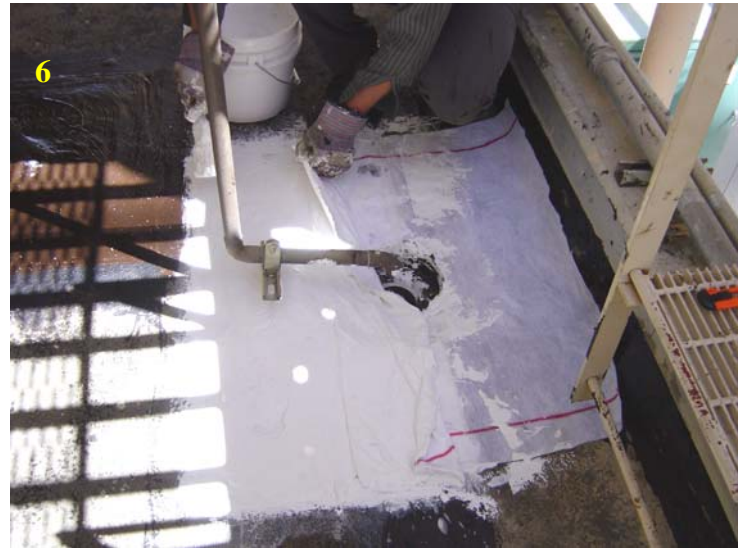
Elastomeric cement and soft polyester waterproof the drain.

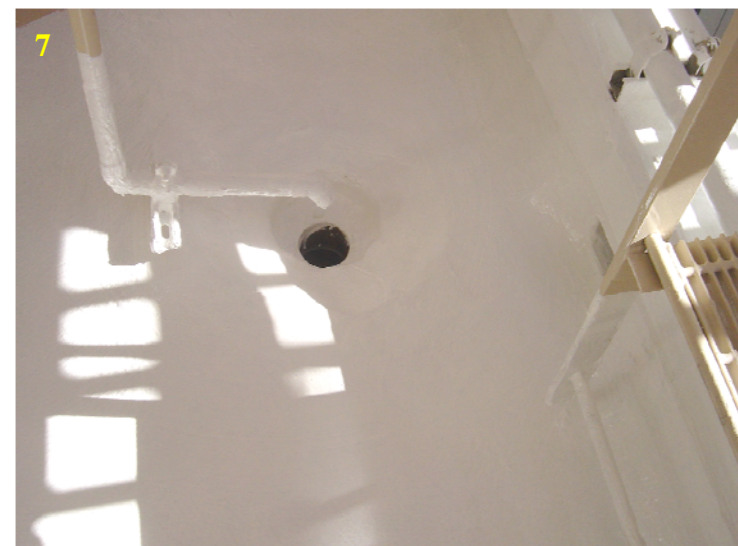
The completed drain. The elastomeric cement and Acu-Shield acrylic coating will keep the roof from splitting even in the harshest winters on the mountain.
