## Can Acrylic Coatings save your Next Roof?

Source/Author: Robert Antrim, Cynthia Johnson, William Kirn, Walter Platek & Karen Sabo

This research paper explains the process of asphalt degradation over time and reveals the performance of acrylic maintenance coatings, site aged for six to 10 years, over both BUR and shingle roofs.

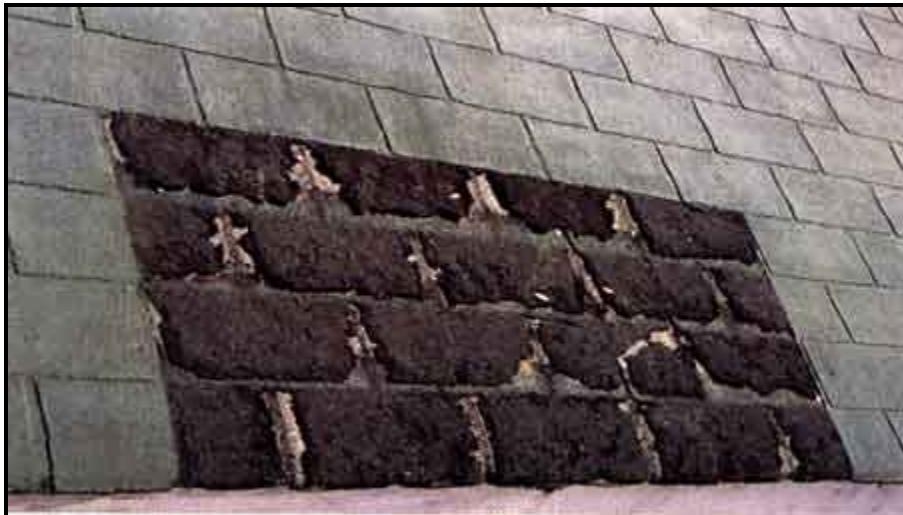
The photograph shows the effects of weathering over a 20-year period on a portion of an untreated asphaltic roof. The remainder of the roof was coated with an all-acrylic elastomeric roof coating about 10 years after it was built, and has resisted additional weathering. (Photo courtesy of Rohm and Haas Co., Philadelphia.)

After seven years of additional exposure in Spring House, PA, the roof was examined. The coated section clearly exhibited virtually no change in appearance, while the uncoated section was severely degraded. Similar experiments with built-up asphalt roofing mock-ups gave comparable results; the coated roof showed virtually no change while the uncoated section was severely degraded.
