Case Study #22: Capsheet Medical products building

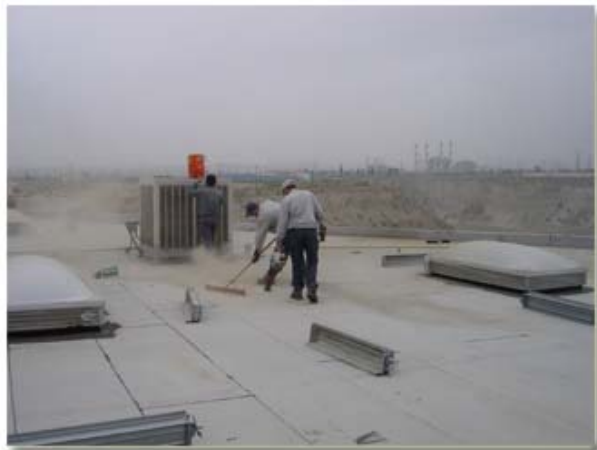
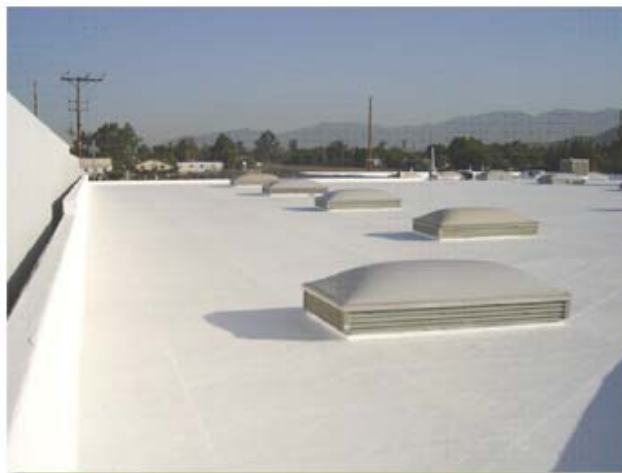
The roof was fourteen years old, nearing the end of its useful life. The skylights, vents, drains and other roof penetrations had been patched several times. These are common places for leaks to start because often when a roof is installed, penetrations are not primed or properly flashed.

The roof was thoroughly cleaned by sweeping and then pressure washing to make sure it is ready for the roof coating system. Some areas of the roof were repaired using EPDM rubber. All roof penetrations were scraped down to bare metal then primed and sealed with Acu-Caulk. All flashing, skylights and drains were detailed in a similar fashion.

Once the roof was properly prepared, Acu-Shield was applied to the entire roof surface. The Acu-Shield will help keep the roof waterproof and will have a significant effect on reducing interior temperatures by reflecting solar heat energy.
