Case Study #35 - Concrete Full Fabric System

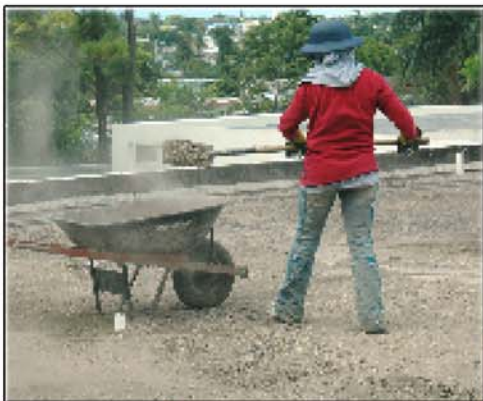
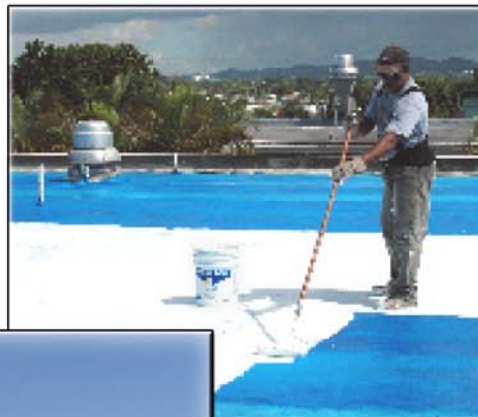
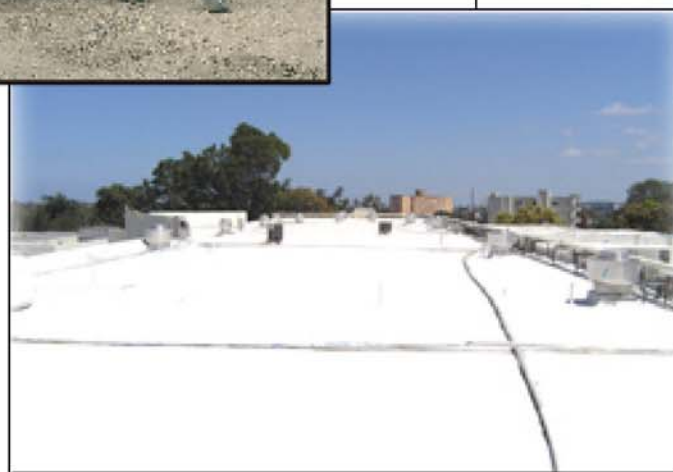
This concrete roof was covered with tar and gravel. The building had been experiencing numerous leaks for years. Leak repairs had been made but were not successful in completely stopping the roof leaks.

After a complete and thorough inspection of the roof, the decision was made to remove all the tar and gravel down to the concrete roof deck. The roof deck was power washed and repairs to the concrete were made. After the roof deck was cleaned and repaired, the Acu-Tac and Acu-Fabric was installed. This system provides a fully adhered seamless single-ply waterproofing system to the roof deck. The entire roof was then top coated with Acu-Shield. The Acu-Shield coating will make the roof system highly solar reflective, reflecting up to 90% of the heat energy from the sun. By increasing the solar reflectance of the roof, the Acu-Shield will help to reduce interior building temperatures and make the building more energy efficient. This system will also greatly extend the service life of this roof.
