# Roof Coatings: White Is The New Green

**W**hat do you do when your “green practices” company headquarters – founded with the goal of saving people money through energy-efficient lighting – is in need of a new roof? The owners of Envirobrite in Sanford, Florida, knew that their leaking 26-gauge, galvanized metal roofs needed attention, but they wanted to approach the roofing project in the most environmentally friendly, energy-wise manner possible.

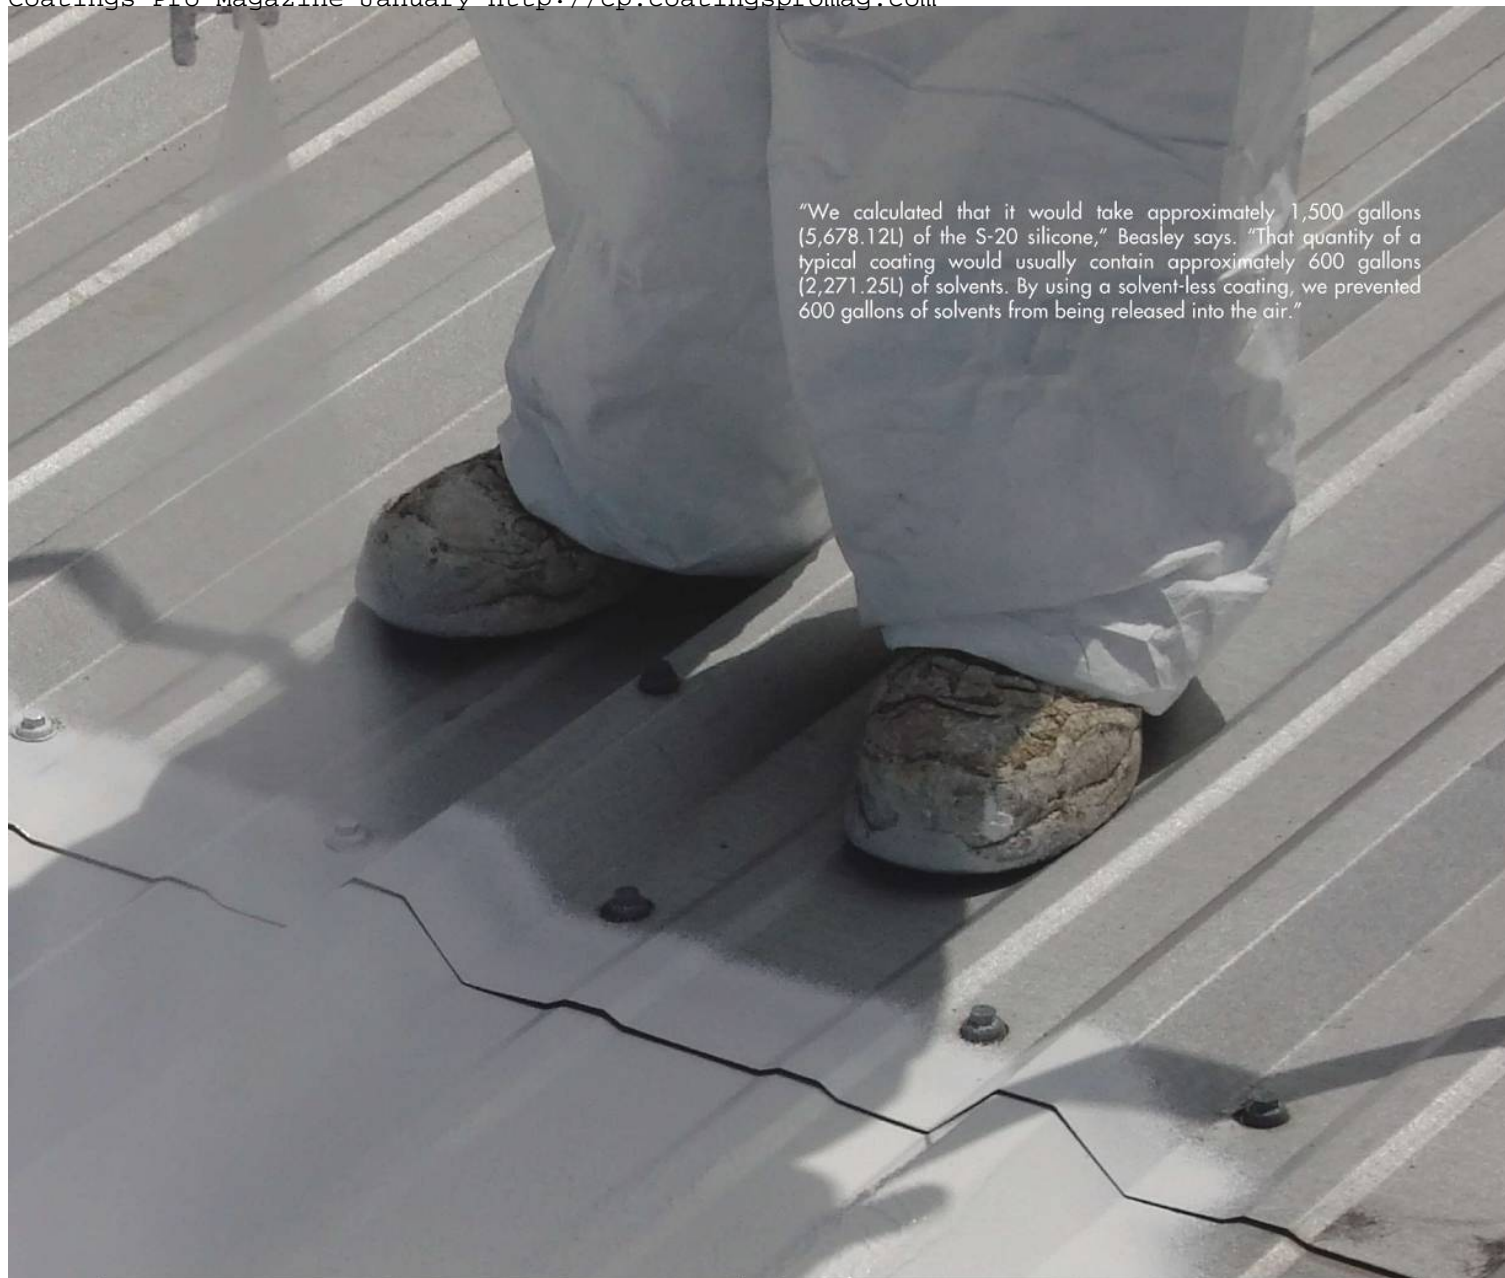
"We calculated that it would take approximately 1,500 gallons (5,678.12L) of the S-20 silicone," Beasley says. "That quantity of a typical coating would usually contain approximately 600 gallons (2,271.25L) of solvents. By using a solvent-less coating, we prevented 600 gallons of solvents from being released into the air."

And not only would the Gaco S-20 save Envirobrite “green” in terms of money, it is formulated to be “green.” “We calculated that it would take approximately 1,500 gallons (5,678.12L) of the S-20 silicone,” Beasley says. “That quantity of a typical coating would usually contain approximately 600 gallons (2,271.25L) of solvents. By using a solvent-less coating, we prevented 600 gallons of solvents from being released into the air.”

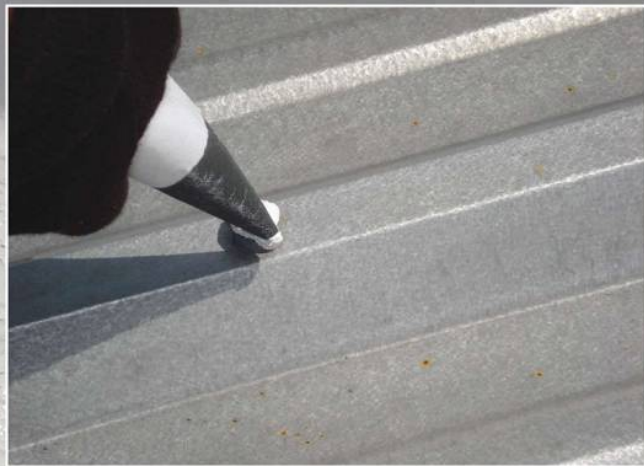
**ABOVE ▲** In order to protect the screws, CCP mixes their own paste-like slurry. "We use Gaco's S-20 silicone mixed with microfibers to make our own caulking that matches the chemistry of the roofing product," Beasley explains.

In order to protect the screws, CCP mixes their own paste-like slurry. “We use Gaco’s S-20 silicone mixed with microfibers to make our own caulking that matches the chemistry of the roofing product.” The crew mixes the caulking on site and hand-applies a “40 to 50 mil (1.02mm to 1.27mm) dollop about the size of a quarter which will then be coated by another 30 mils (0.76mm) of the coating system,” Beasley explains.

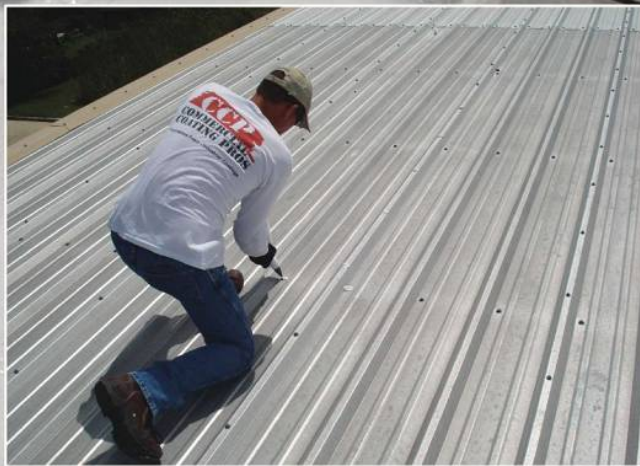
**ABOVE ▲** Beasley asks, "Do you know what your back does when you're bent over for six straight days doing screws? Brutal. But it is so important because that's where those leaks come from...thousands of heat cycles – hot, cold – those screws just pop."

But it was after the “problem areas” were addressed that the job got rough. The crew had to encapsulate each and every one of those 80,000 screw heads — by hand. Beasley asks, “Do you know what your back does when you’re bent over for six straight days doing

screws? Brutal. But it is so important because that’s where those leaks come from...thousands of heat cycles — hot, cold — those screws just pop.”

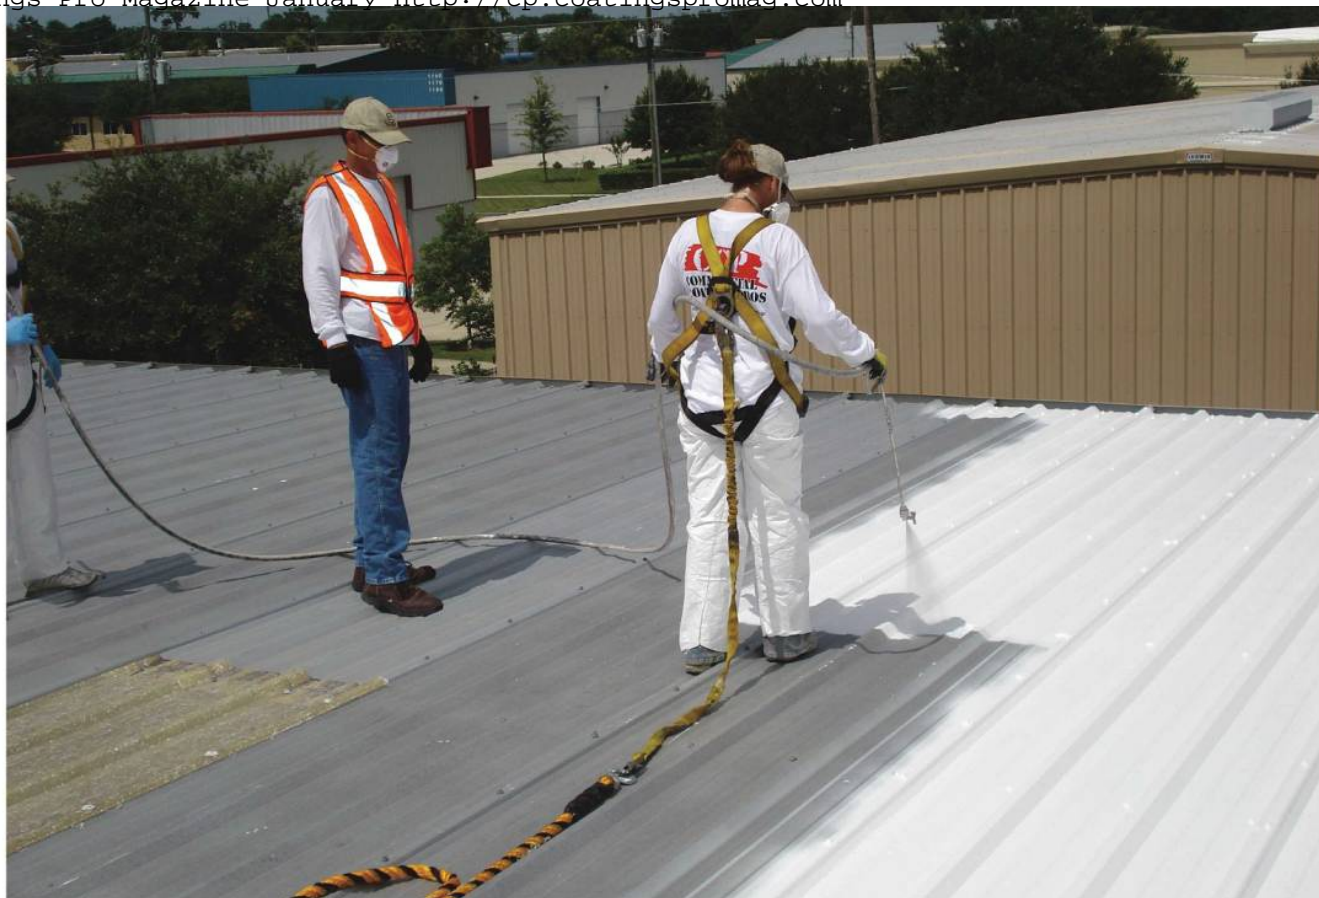
**LEFT** ◀ The crew used a Graco X-70 and a Graco 56:1 Bulldog to apply the Gaco Western S-20 solventless silicone coating system in white at a thickness of 30 mils (0.76mm) DFT to the entire surface of both roofs.

After some well-earned back stretches, the crew was ready for the last step, applying that 30 mil (0.76mm) DFT coating system. Using a Graco X-70 and a Graco 56:1 Bulldog, the CCP crew applied the Gaco Western’s S-20 solventless silicone in white to the entire roof surface. Working both roofs took six days. Beasley recounts that the elastomeric roof coating stays so cool that it was “nearly impossible to dry because it develops no heat. The finished roof will not evaporate dew.” That is one cool roof.

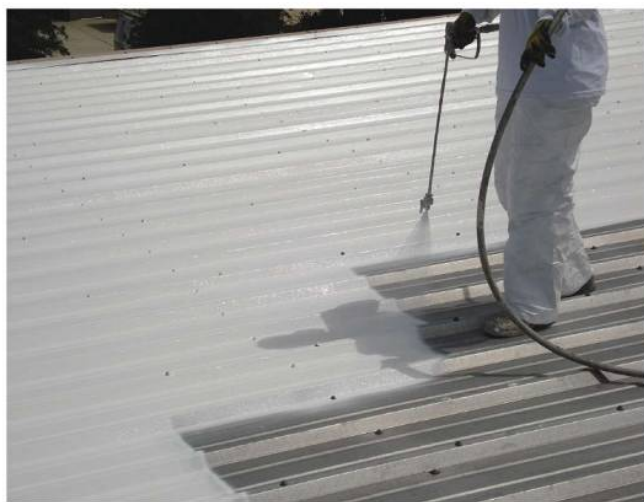
**ABOVE** ▲ Prior to the top coat application, the crew spray-applied Gaco Western's GacoFlex E-5320 epoxy primer to the roof surface at a rate of 1 gallon per 300 square feet (1L per 27.87m<sup>2</sup>). They also applied 2,500 board feet of Gaco Western PolyFoam 273 spray polyurethane foam onto the "problem areas: wall tie-ins, ridge caps, and equipment penetrations."

Once all of the fasteners had been inspected and tightened or replaced, it was time to apply the primer. Using a Graco HydraMax 300, the crew spray-applied Gaco Western’s GacoFlex E-5320 epoxy primer to the roof surface at a rate of 1 gallon per 300 square feet (1L per 27.87m<sup>2</sup>).

The primer was followed by the application of 2,500 board feet of Gaco Western PolyFoam 273 spray polyurethane foam onto the “problem areas: wall tie-ins, ridge caps, and equipment penetrations.” Beasley explains that: “We use a custom-made roofing foam proportioner from Polymer Processing, Inc. to spray-apply an average of 1” to 4” (2.54cm to 10.16cm) of SPF in some areas and to create a curve at transitions. We’ve found that SPF applied in these typically problem areas creates a tough, durable bridge that coating alone sometimes cannot manage.”

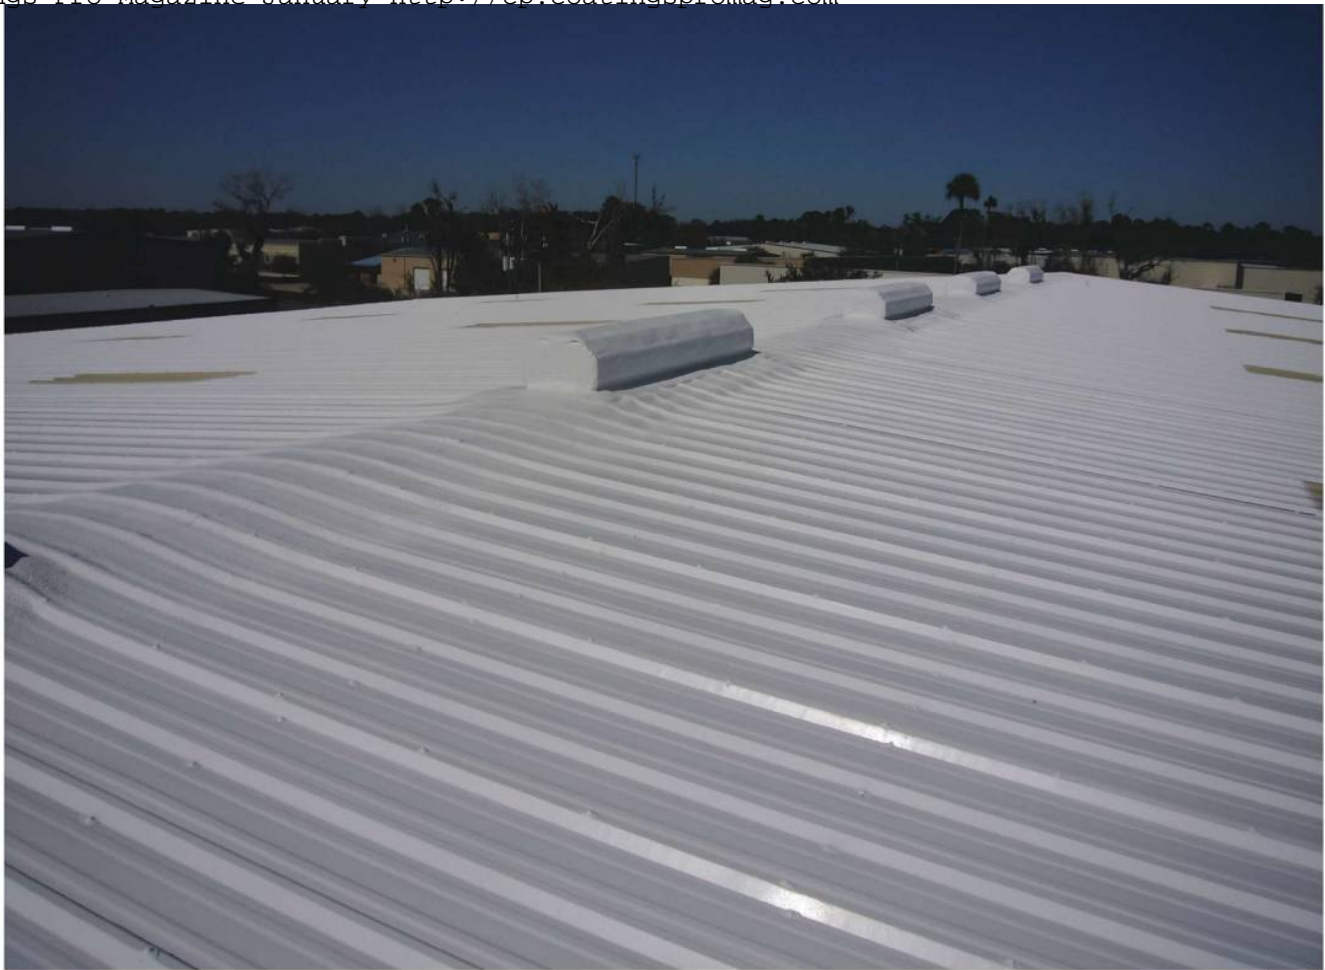
**ABOVE ▲** Beasley says that the Gaco Western S-20 roof coating was “nearly impossible to dry because it develops no heat. The finished roof will not evaporate dew.”
