How to.... Maintain your roof Forever

Extra Tough Roof Maintenance System

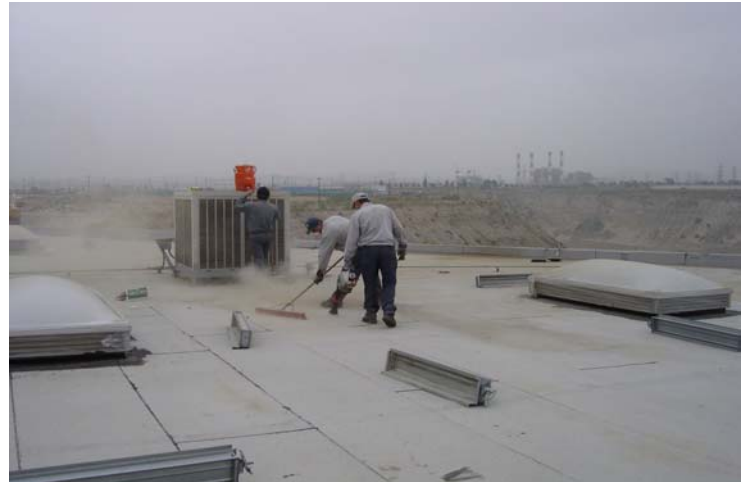
Cleaning the roof for the new polyester and emulsion roof system.

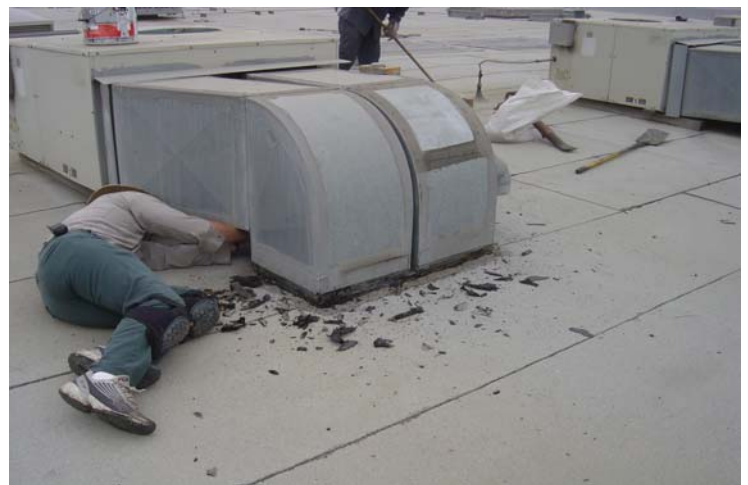
All penetrations are scraped down.

A 2-ply polyester maintenance roof system was installed directly to the existing roof. Roof top penetrations were scraped down to bare metal, primed and sealed with Acu-Caulk. Emulsion and Acu-Fabric polyester were applied. Acu-Shield, one of the best white acrylics on the market from Advanced Coating, finished the job.

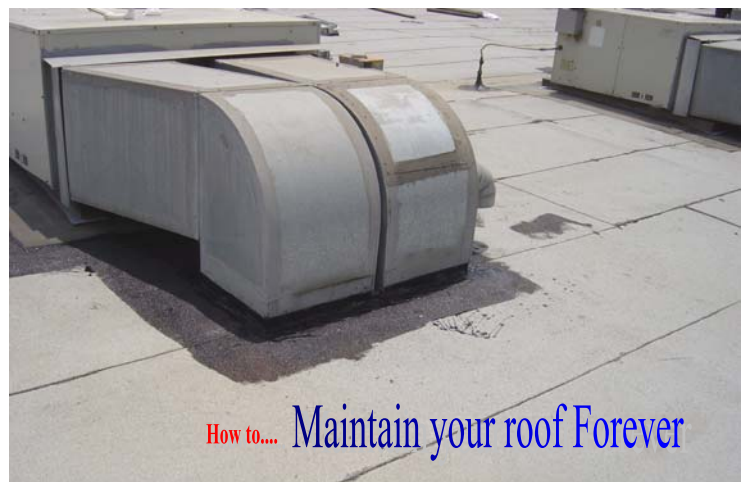
All penetrations are primed to create a solid long lasting bond to the new maintenance roof.

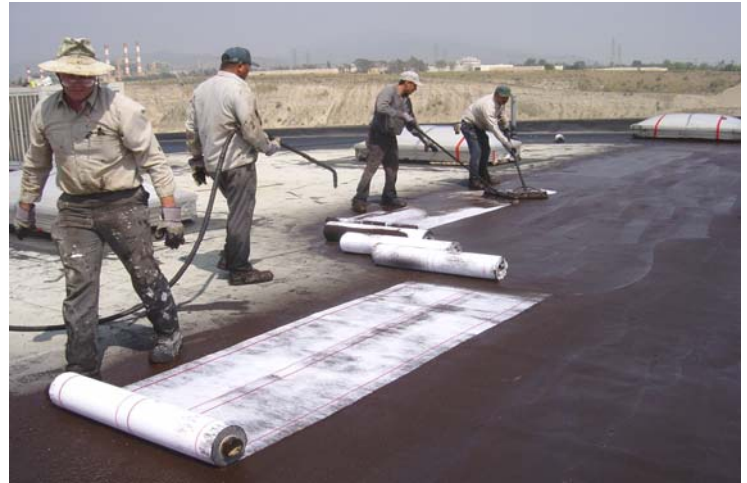
2 layers of extra tough *Acu-Fabric* are bonded to the existing roof.

Polyester ply sheets are much tougher than conventional fiberglass. They have the ability to expand and contract without splitting on a large roof like the roof at the Nu-Hope facility.

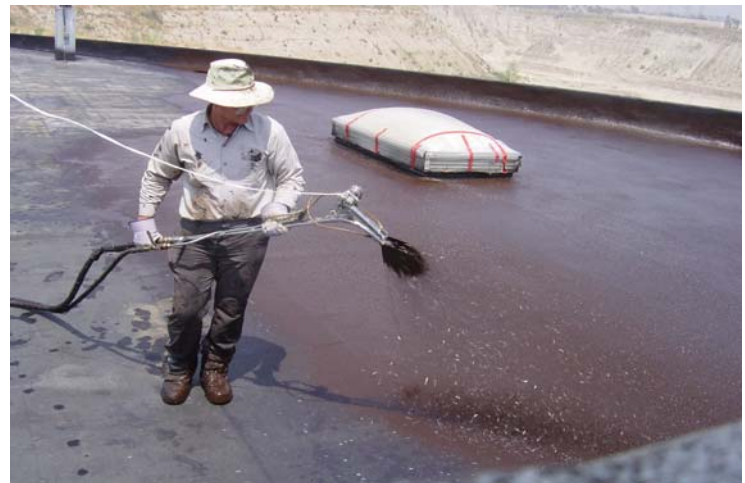
Fiberglass roving is chopped through a special gun at the same time the emulsion is applied. This creates a thick waterproof barrier that water cannot penetrate.

Emulsion is a mixture of pure asphalt and bentonite clay. It is far superior to asphalt that is used in hot applied roofs. Emulsion seals off the roof and creates a thick waterproofing layer that will slow the aging process by keeping the roof pliable.

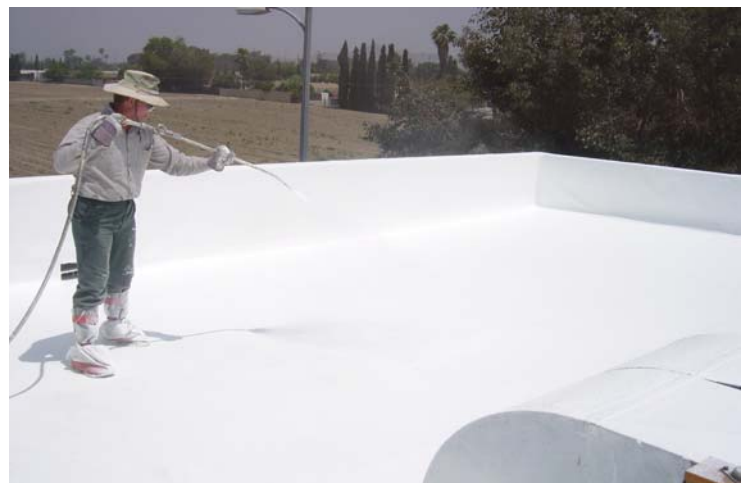
2 layers of *Acu-Shield* white coating are sprayed onto the roof. This will reduce temperatures and save money.

Century Roofing used **Energy Seal Coating's *Acu-Shield***, one of the best acrylic coatings available. The coating will cut the heat on the roof by up to 80° on hot summer days. White acrylic coatings can save up to 50% on cooling bills.

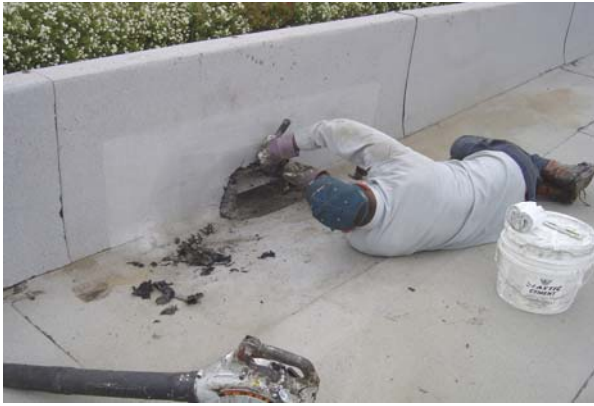
1st photo. The existing drain is cut back.

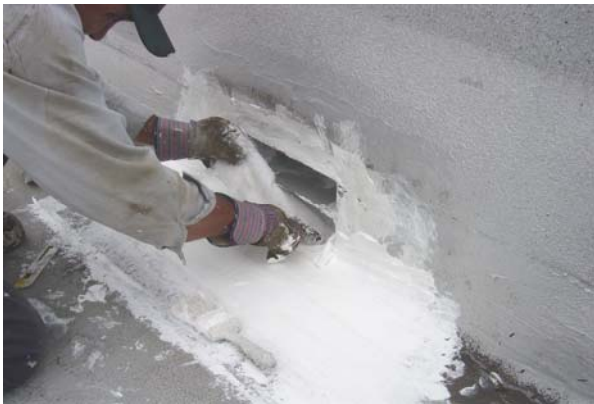
2nd photo. Acu-Fabric and Acu-Caulk were installed in the drain. The rubbery Acu-Caulk will move with the roof. The Acu-Fabric will prevent the drain from ever splitting

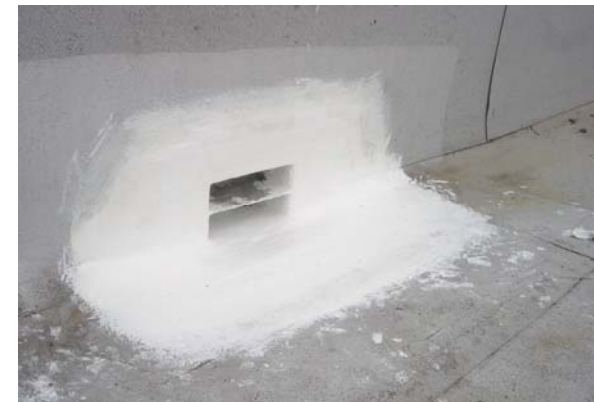
3rd photo. The Drain is now prepared and ready for the new roof system.

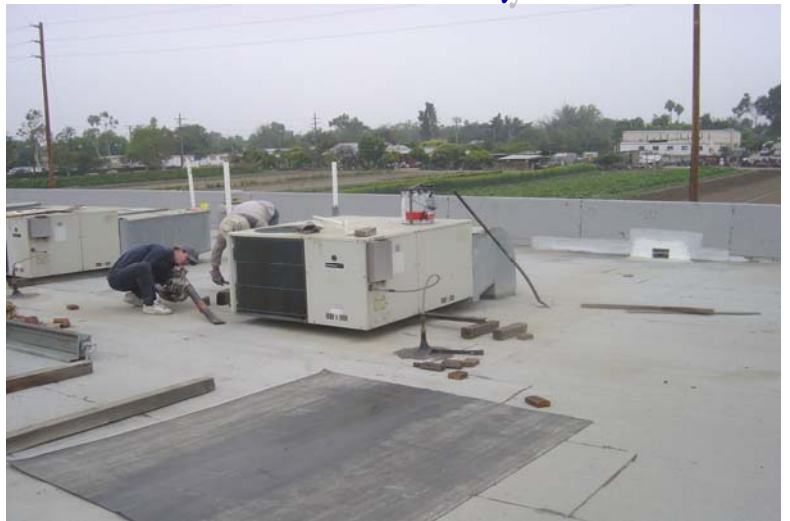
Each a/c unit needed to be prepared. All units were raised, dirt and debris were cleaned from underneath.

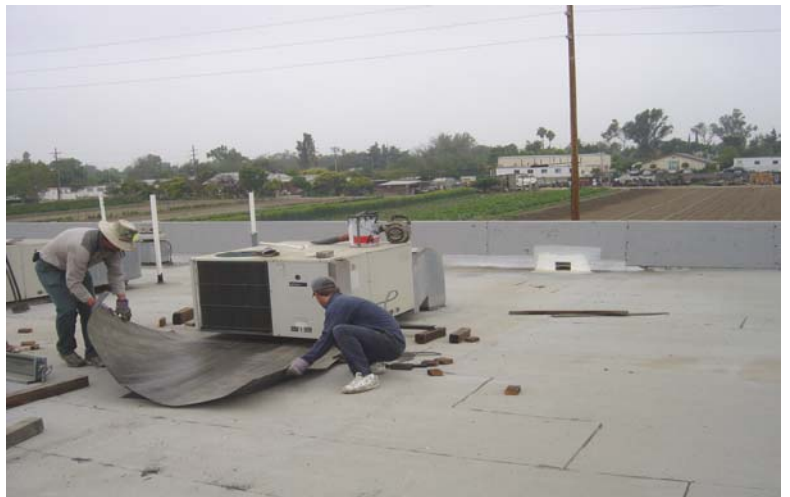
A 2 ply modified bitumen sheet was set under each a/c unit.

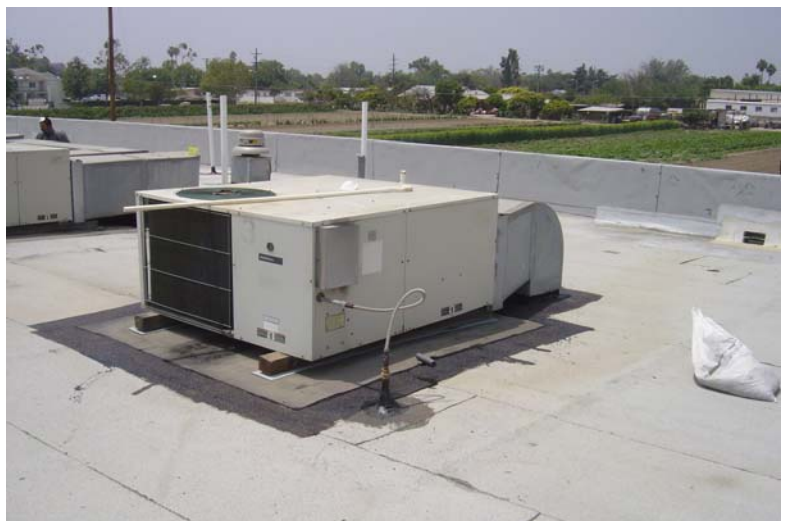
The modified bitumen sheet was sealed to the roof and the wood sleepers are set on pads. The perimeter is primed and ready for the new maintenance roof.

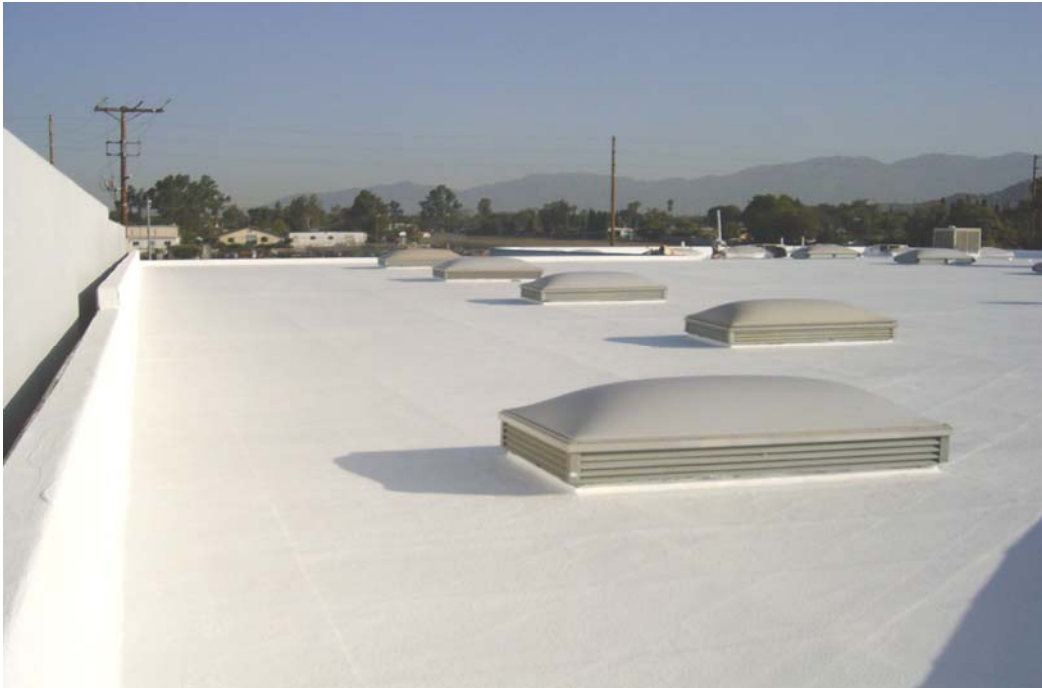
The Finished Roof

The roof will reflect heat and block ultra violet light. Every decade or so an additional coating will keep the roof in tip- top shape.

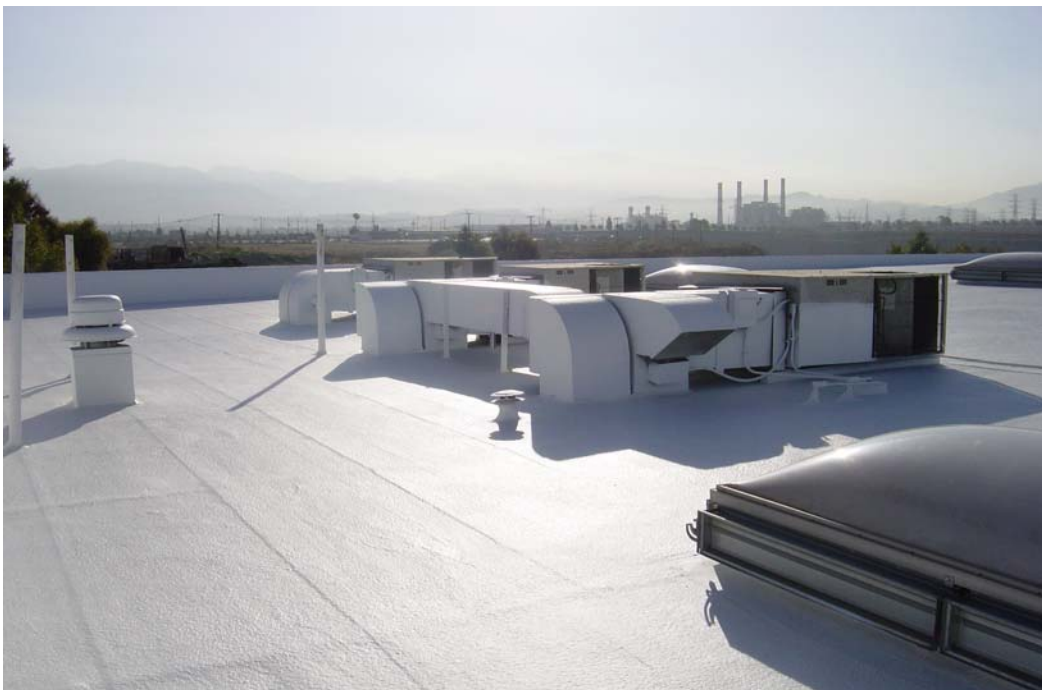
The Acu-Shield will save a tremendous amount of money on cooling costs and greatly extend the service life of this roof.
