Polyurethane Foam Roof Coating / Restoration

Source/Author: Rohm & Haas Company

Name: Rohm and Haas Bristol Plant Building

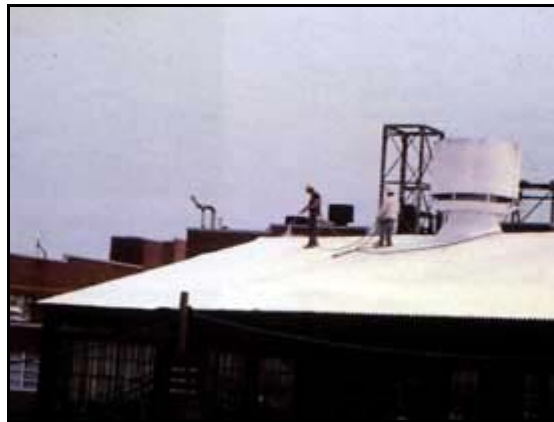
Even in a heavy industrial environment, the roof mastic based on RHOPLEX EC acrylic will retain its white, reflective color.

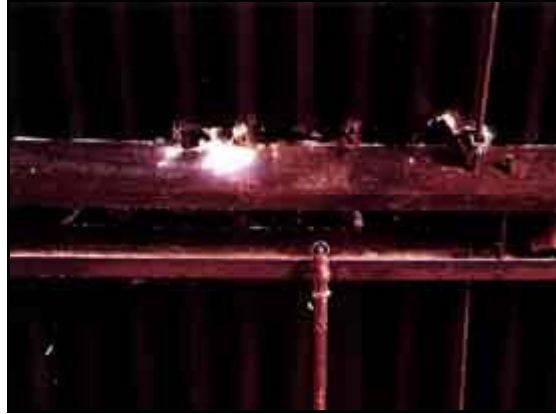
Constant expanding and contracting of the metal roof due to temperature changes led to splits in the panel seams. This photograph was taken from inside of the building looking up.

Condition: Constant expansion and contraction of the metal roof due to temperature changes caused splits in the panel seams and deterioration of the asphalt and felts. This caused leakage from holes, open seams, and rust spots. In many areas, rust spots had turned into holes.

Preparation: The metal roof was brushed clean. In some cases, galvanized steel panels were used to patch large holes in the roof. A contact adhesive-foam bond primer-was sprayed on the new steel to enable the foam to adhere to the steel. One-inch minimum of three pound density rigid polyurethane foam was sprayed on top of the repaired roof.

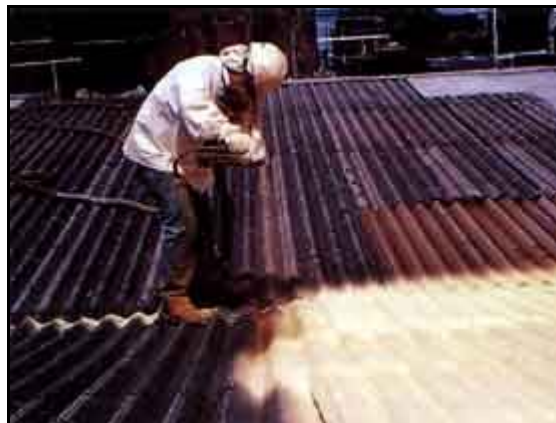
The repaired corrugated metal roof receives a polyurethane foam application, which forms a seamless water tight seal over the roof.

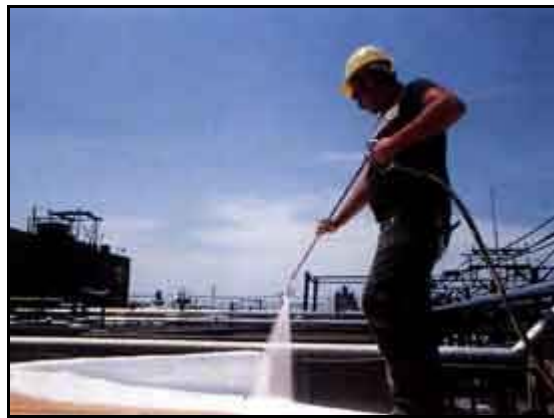
Elastomeric roof mastics based on RHOPLEX EC acrylic prolong the life of polyurethane foam by protecting it from ultraviolet degradation.
